June 1945 as
Advance Restricted Report L5F01a

EFFECT OF FABRIC DEFLECTION AT HIGH SPEEDS ON THE
AERODYNAMIC CHARACTERISTICS OF THE HORIZONTAL
TAIL SURFACE OF AN SB2D-1 AIRPLANE

By Carl F. Schueller and Peter F. Korycinski

Langley Memorial Aeronautical Laboratory
Langley Field, Va.

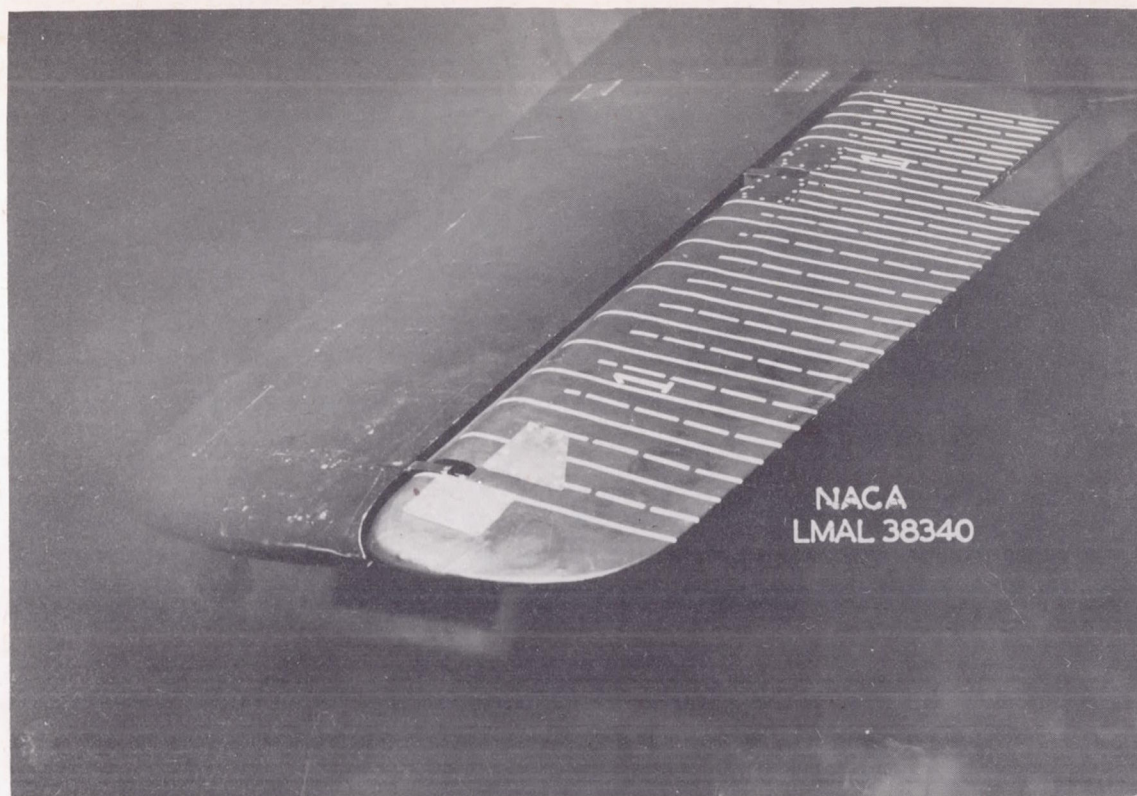
Elevator 1.- Figure 8 is a photograph of the fabric deflection on the upper surface of elevator 1 (4-inch rib spacing) at $\alpha = 0^\circ$, $\delta = 4.2^\circ$, and $M = 0.66$. The fabric deflection is not appreciable at any point along the elevator except for a small bulge occurring near the inboard hinge. No other photographs are shown for this elevator because the fabric deflection was not serious during any of the tests with this elevator.

Figure 8.- Fabric deflection of upper surface of elevator 1
(4-inch rib spacing). $M = 0.66$; $\alpha = 0^\circ$; $\delta = 4.2^\circ$; elevator
vents at trailing edge.

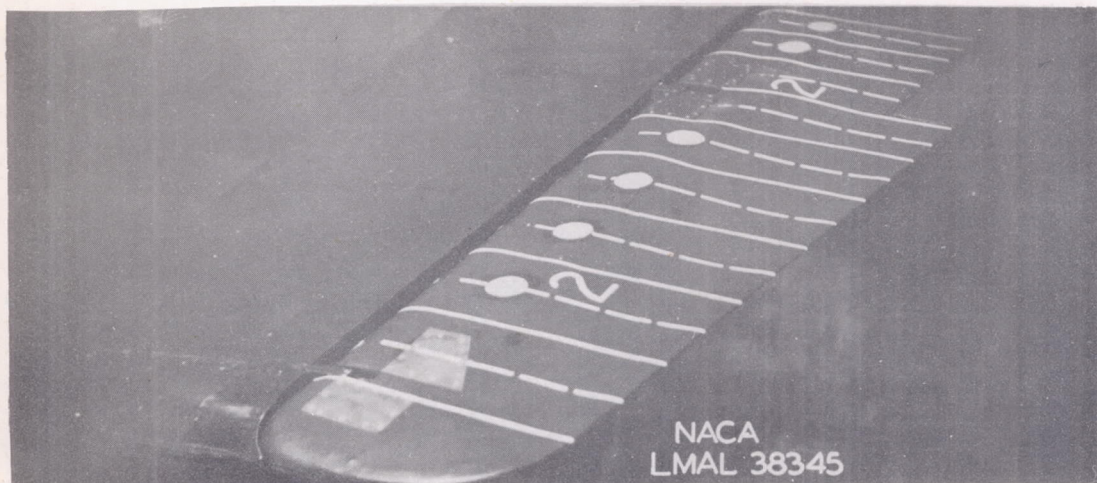
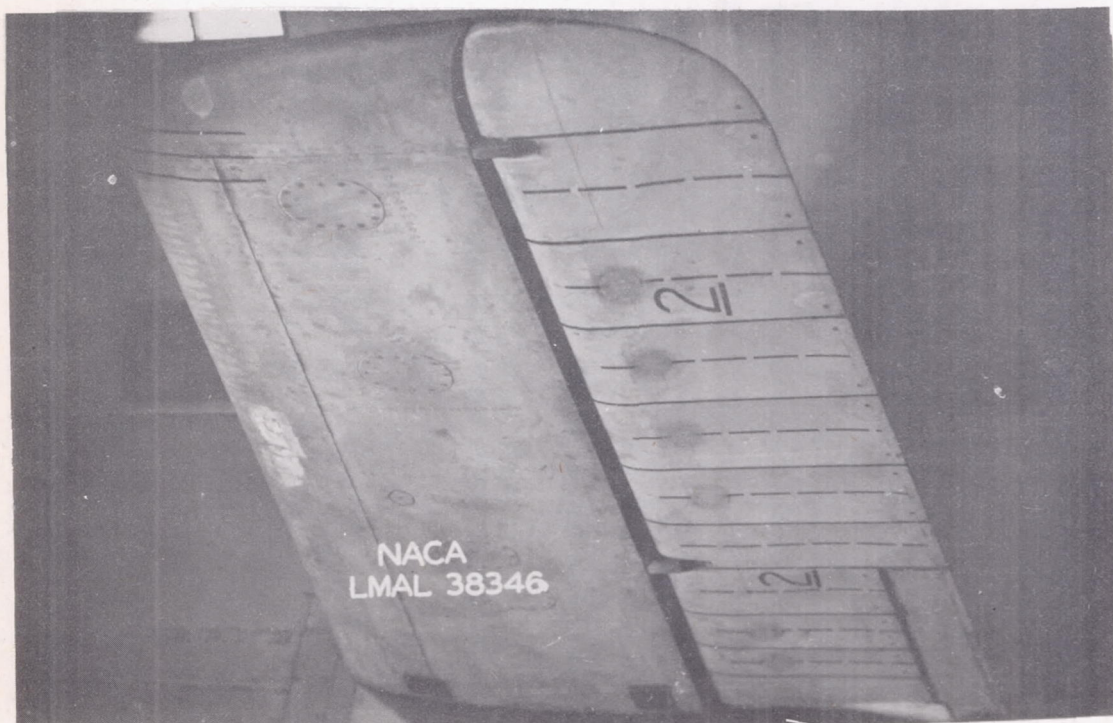
Elevator 2.- Figure 9 is a photograph of the fabric deflection of both surfaces of elevator 2 (8-inch rib spacing) at $\alpha = 0^\circ$, $\delta = 3.3^\circ$, and $M = 0.55$. Considerable bulge occurred on the top surface behind the hinge line. This bulge changed to depression on the rear part of the elevator. Since the fabric was sewed to the elevator ribs, the solid stripes should show no deflection. A number of solid stripes, however, are deflected. (See fig. 9(a).) Deflection of the solid stripes indicates failure of the fabric attachment at these points and is the beginning of a condition that would result in complete failure of the surface if the air loads were increased. Figure 10 is a photograph of the fabric deflection at $\alpha = 3^\circ$, $\delta = -0.7^\circ$, and $M = 0.62$. In general, the upper surface is slightly bulged just behind the hinge line. The most serious bulge occurs at the inboard hinge and is believed to be a result of weak fabric attachment around the hinge-pocket cut-out rather than of local-suction peak pressures. Figure 10 also shows the fabric pulled away from the ribs. (Note solid stripes.)

Figure 9.- Fabric deflection of elevator 2 (8-inch rib spacing).
 $M = 0.55$; $\alpha = 0^\circ$; $\delta = 3.3^\circ$; elevator seal removed; elevator
vents at trailing edge.

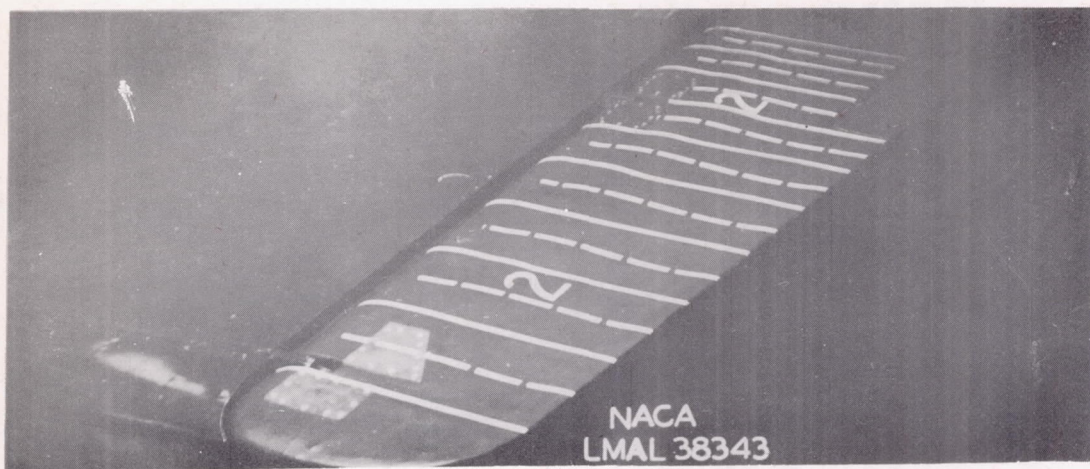
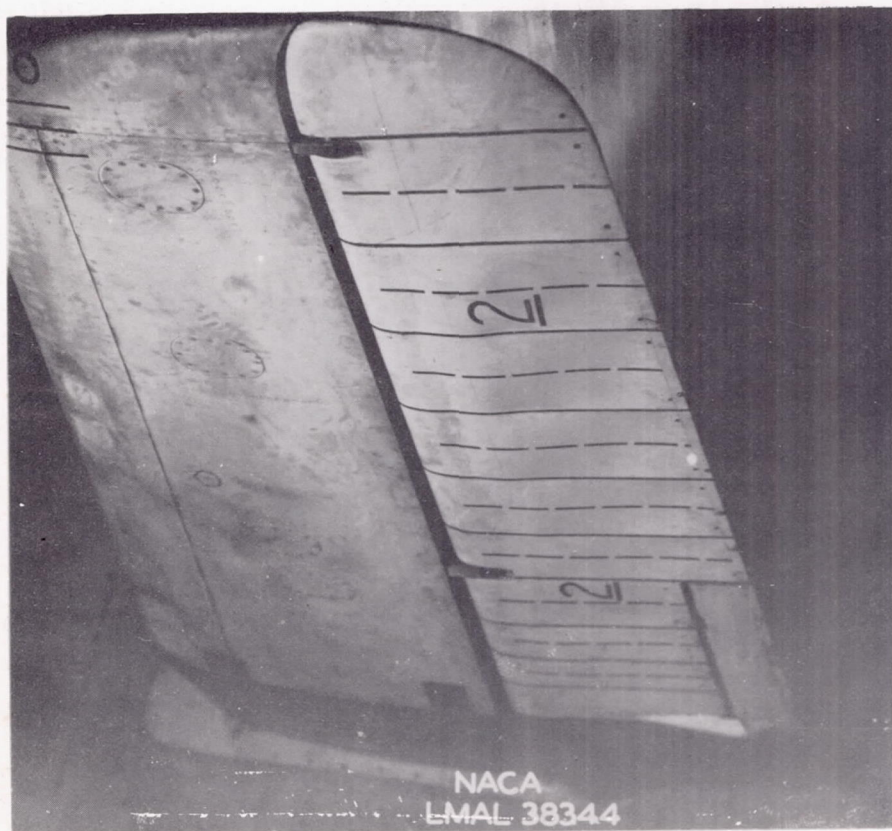
Figure 10.- Fabric deflection of elevator 2. $M = 0.62$;
 $\alpha = 3^\circ$; $\delta = -0.7^\circ$; elevator vents at trailing edge.

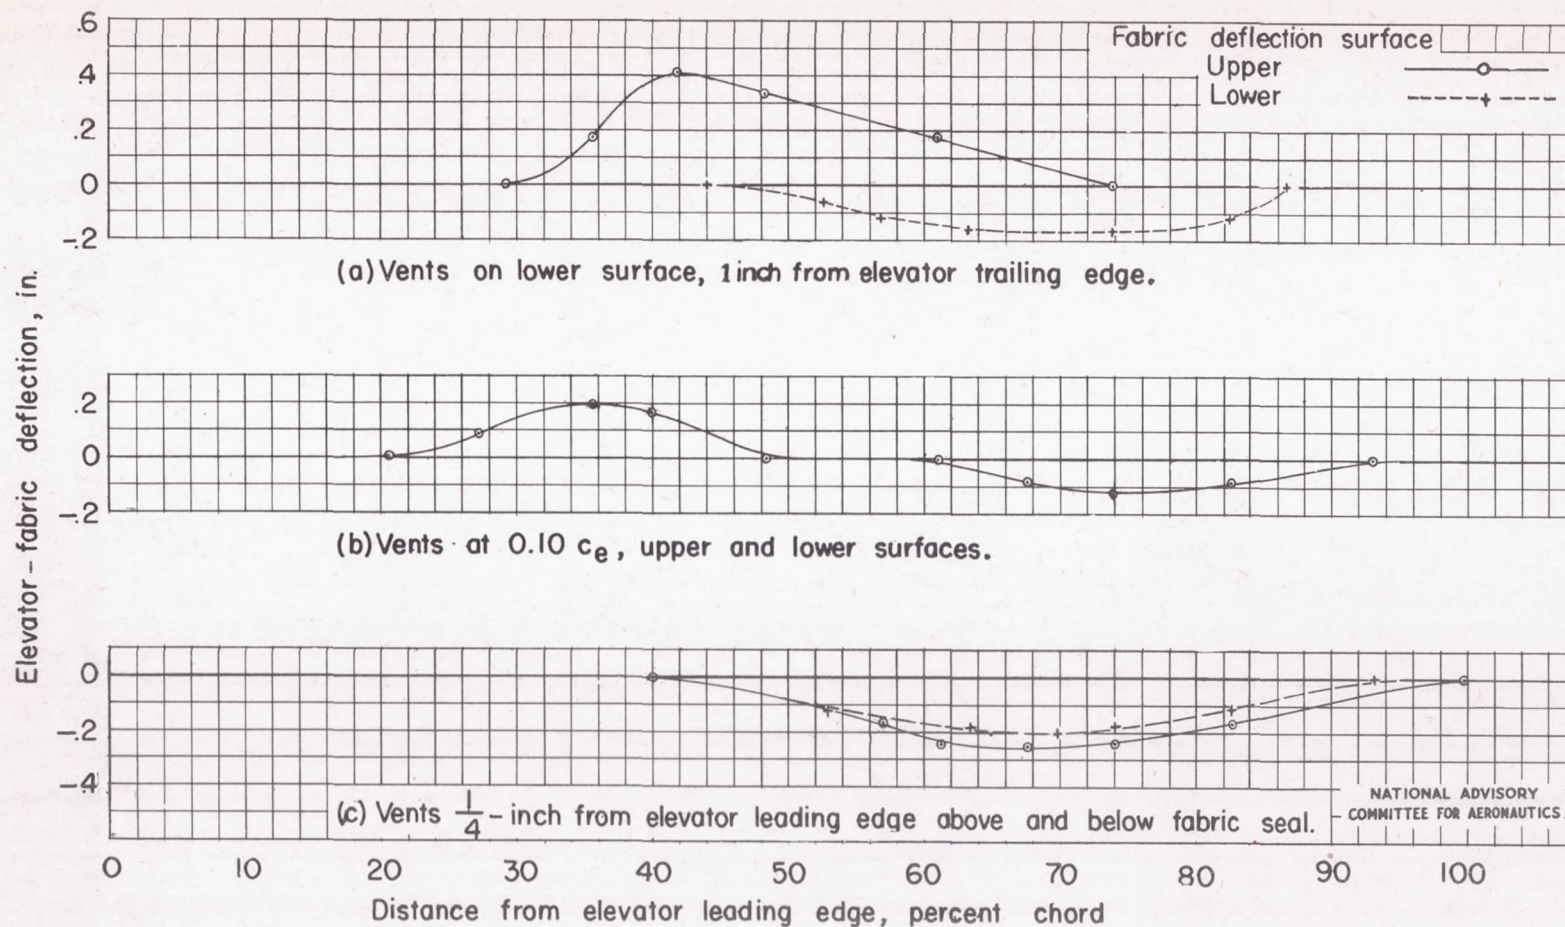
Figure 19 presents quantitative comparisons of the fabric deflection along the elevator chord for the three vent locations at $\alpha = 0^\circ$, $\delta = 4^\circ$, and $M = 0.55$. The maximum bulge on the upper surface is reduced from 0.4 inch for the original vent configuration to 0.2 inch by using vents at 10 percent of c_e and to 0.26-inch depression with vents at the elevator leading edge. No measurements were made for the lower surface with vents at 10 percent of c_e but visual observation indicated that the fabric was depressed for this condition, as would be expected.

Figure 19.—The variation of the fabric deflection along the chord of elevator 2 at 51.5-inch station for three vent configurations. $\alpha = 0^\circ$; $\delta = 4^\circ$; $M = 0.55$. (Positive deflections denote fabric bulge and negative deflections denote fabric depression.)

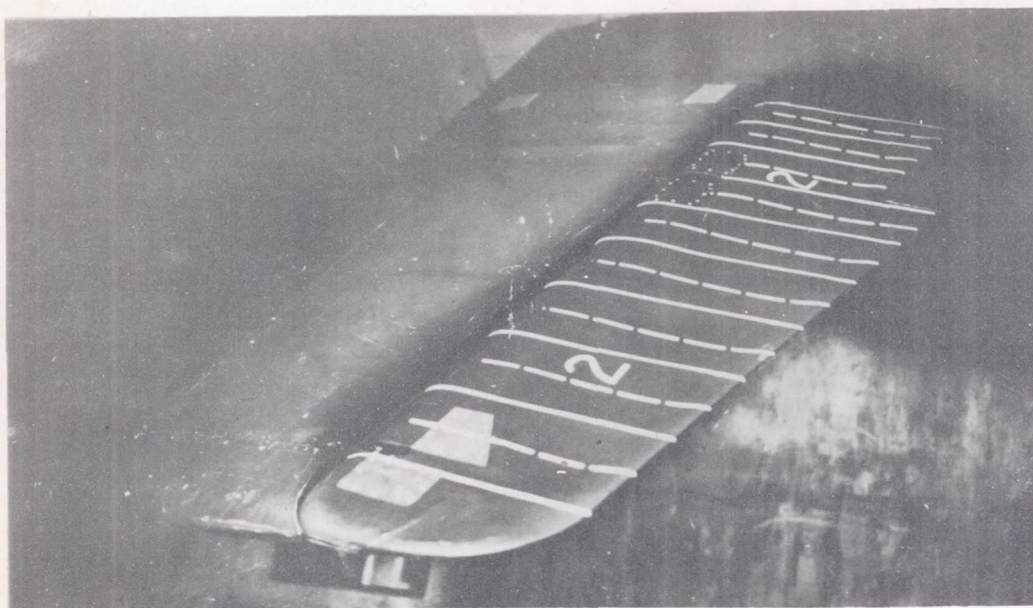
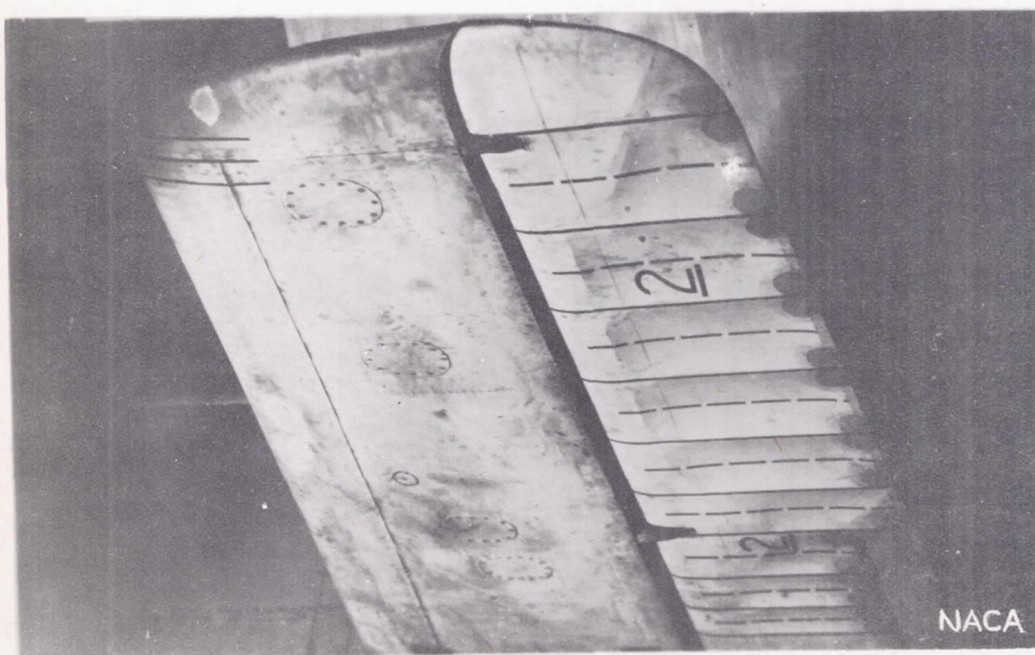
Figure 20 is a photograph of the fabric deflection with vents at the elevator leading edge for $\alpha = 0^\circ$, $\delta = 4^\circ$, and $M = 0.55$. Comparison of figures 20 and 9 shows that the upper-surface bulge is changed to depression with vents at the elevator leading edge, except for a small local bulge at the upper surface near the inboard hinge. It is apparent from figures 19 and 20 that location of the vents at the elevator leading edge will eliminate the danger of the fabric pulling loose from the ribs and failing for elevator angles up to at least 4° .

Figure 20.- Fabric deflection of elevator 2. $M = 0.55$;
 $\alpha = 0^\circ$; $\delta = 4^\circ$; elevator vents at leading edge.

2. Vent holes located at the elevator leading edge on either side of the seal, rather than in their original position on the lower surface near the trailing edge, eliminated the bulge for a moderate range of elevator angle at the expense, however, of some increase in fabric depression on the pressure side of the elevator.
